DC-TR: 2-58

METALLURGICAL TESTING AND PENETRATION PERFORMANCE
OF THIN-NOSED 750-POUND T54E3 DEMOLITION BOMBS
MANUFACTURED BY THE WALSH CONSTRUCTION COMPANY
OF PORTLAND, MAINE

JUNE 1958

PICATINNY ARSENAL — DOVER, NEW JERSEY

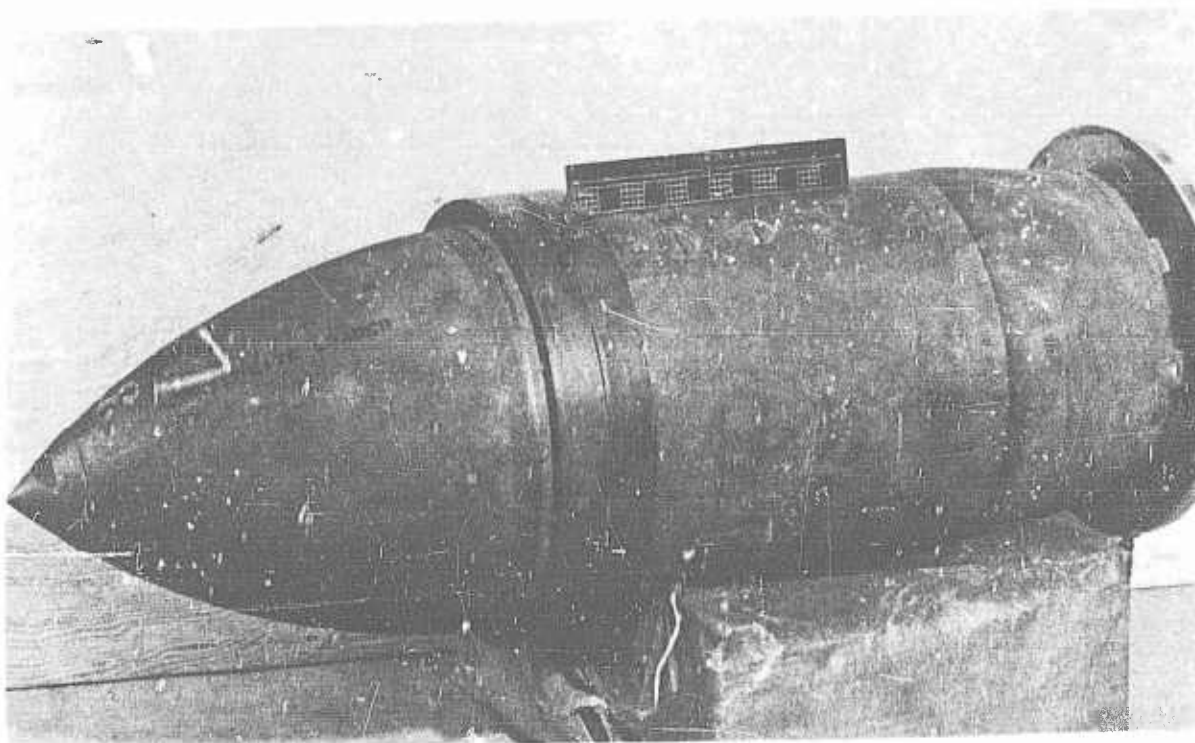
FRONTISPIECE: Walsh 750-Pound, T54E3, Demolition Bomb, Modified for Gun-Firing Tests by Addition of Two Cloth Tape Bourrelets and an Aluminum Pusher Plate.

55. To increase the diameter of the bombs to gun bore diameter and seal against the escape of propellant gases, an aluminum pusher plate (Fig. 26) and a four-inch cloth tape bourrelet were placed on each bomb. The pusher plate, attached with four $\frac{1}{2}$ -inch bolts, was designed to strip off upon target impact without damage to the bomb body. The bombs were provided with regular conical steel nose plugs, and the fuze wells were left empty.*

* NOTE: Bomb labeled "Vermiculite" on Frontispiece typifies description in paragraph 55, and does not pertain to loading described in paragraph 54.

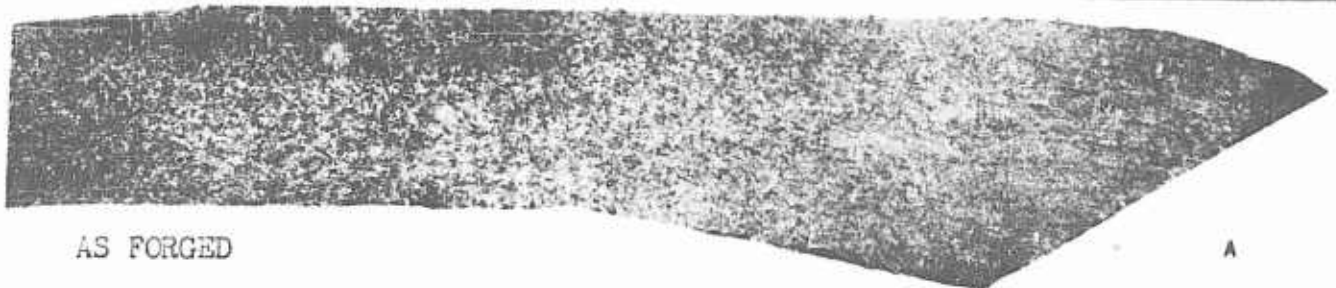
12. Macroscopic Examination: Longitudinal sections were machined from the ogive and body of each casing, then surface-ground and etched in a hot solution of HCl and H₂O. The resulting macrostructures (Figs. 1 and 2) were typical of good quality hot-rolled steel. In Casings B and C the flow pattern of the forged ogive sections was more pronounced than in Casing A. Numerous fine cracks (resulting from the ogive-forming operation) were on both the interior and the exterior surfaces of the B and C casing ogives.

Fig. 2: Hot-Acid Macroetched Sections from Ogives of T54 Bomb Casings A, B, and C, Manufactured by the Walsh Construction Company.

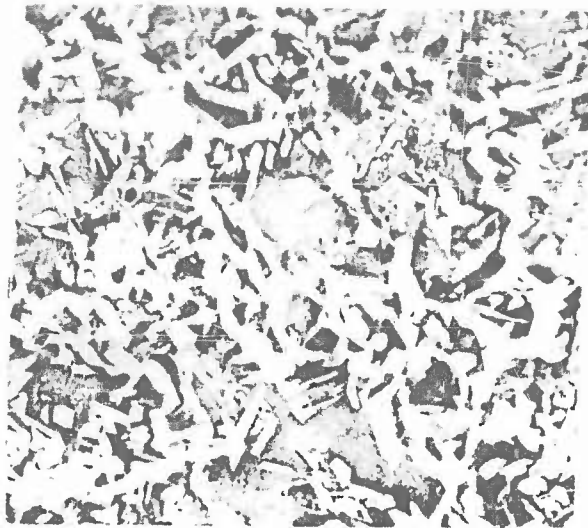
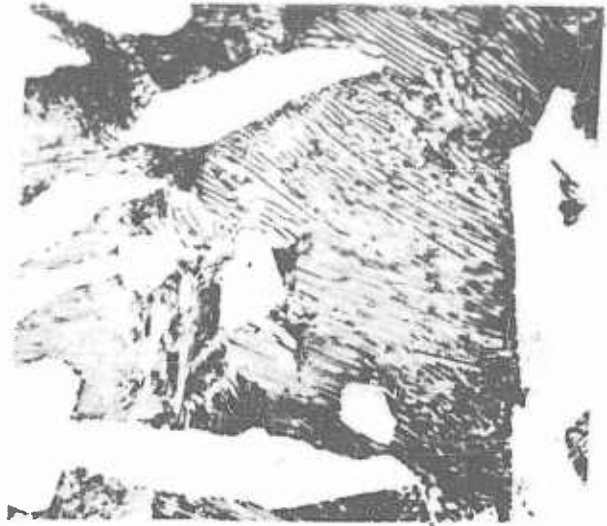
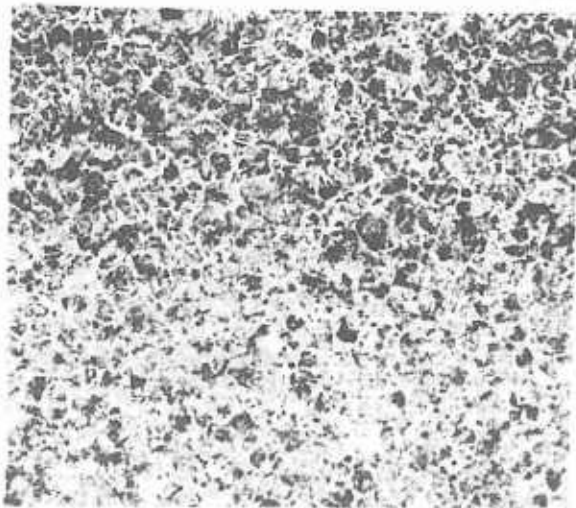
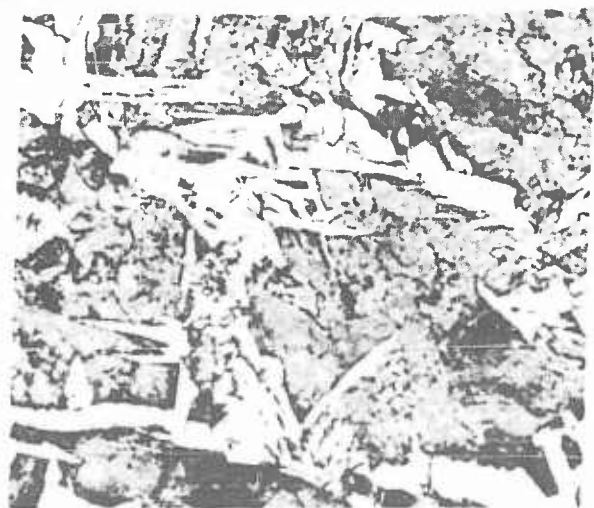
13. Microscopic Examination: Specimens were machined from the ogive and body of each casing. In Casing A (Fig. 4), microscopic examination revealed very little difference in the microstructure in either location; both areas consisted of fine pearlite and ferrite. The structures were typical of hot-worked steel, slowly cooled from the forging temperature in air. Casings B and C had structures in the body consisting of tempered bainite, with some traces of martensite in B and considerable rejected

X100 -A-
Coarse-Grained Structure of Hot-
Worked Steel.

X1000 -B-
Fine Pearlite and Ferrite in
Same Area as -A-.

X100 -C-
Moderate Grain Size.

X1000 -D-
Ferrite, Bainite, and Fine Pearl-
ite in Same Area as -C-.

Fig. 4. Microstructures of Ogive Sections From Casings A, B,
and C.

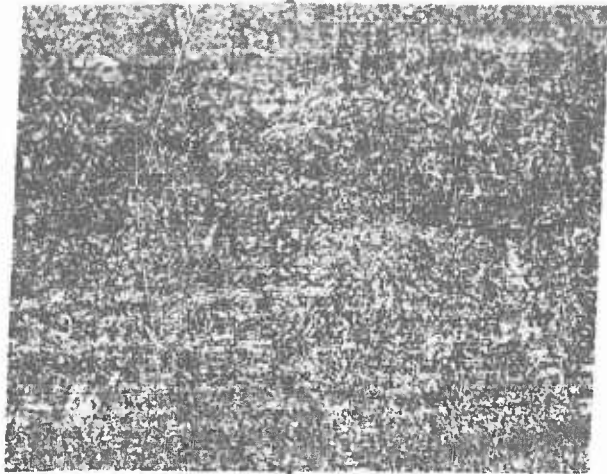
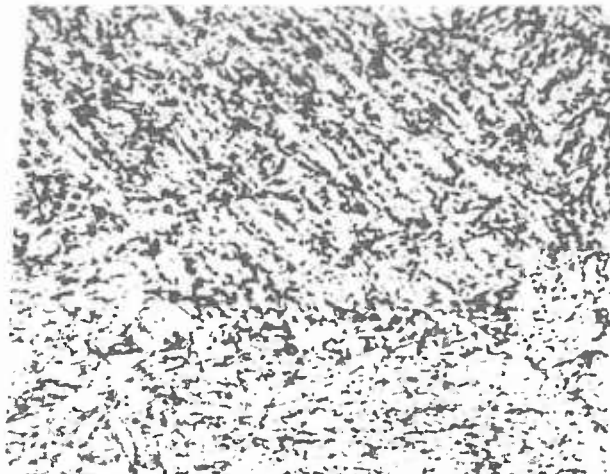
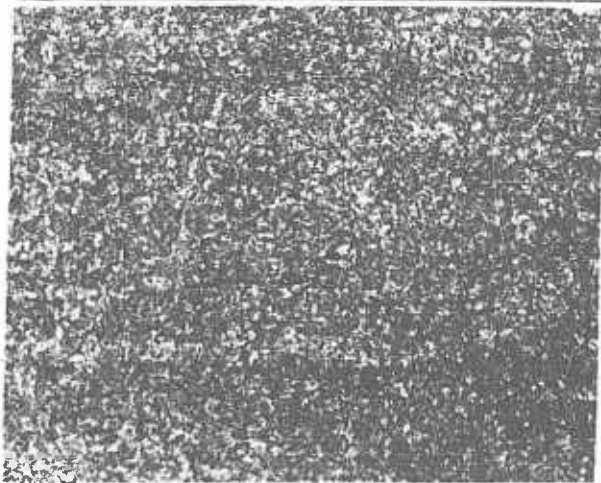
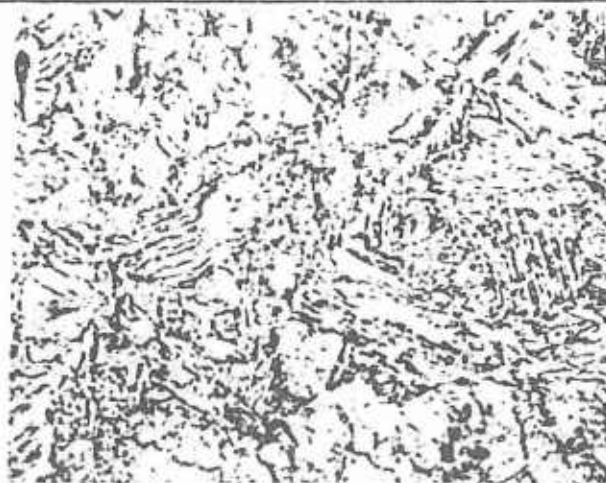
Fine-Grained, Slightly Banded Structure.

Tempered Structure of Bainite and Some Martensite.

Fine Grained Structure with Some Elongated Non-Metallic Inclusion.

Tempered Bainite and Grain Boundary Ferrite.

Fig. 5. Microstructures from Bodies of Bomb Casings B and C.

39. Microscopic examination indicated that the ogive and body structure of Casing A was consistent with the mechanical properties of the casing which had approximately a 55-percent yield to tensile strength ratio. The structure of the body of Casing C indicated that the austenitizing treatment was not performed with as drastic a quench as employed for Casing B. This accounts for the ferrite rejection. Again, the yield to tensile strength ratios are consistent with the microstructures of Casings B and C.

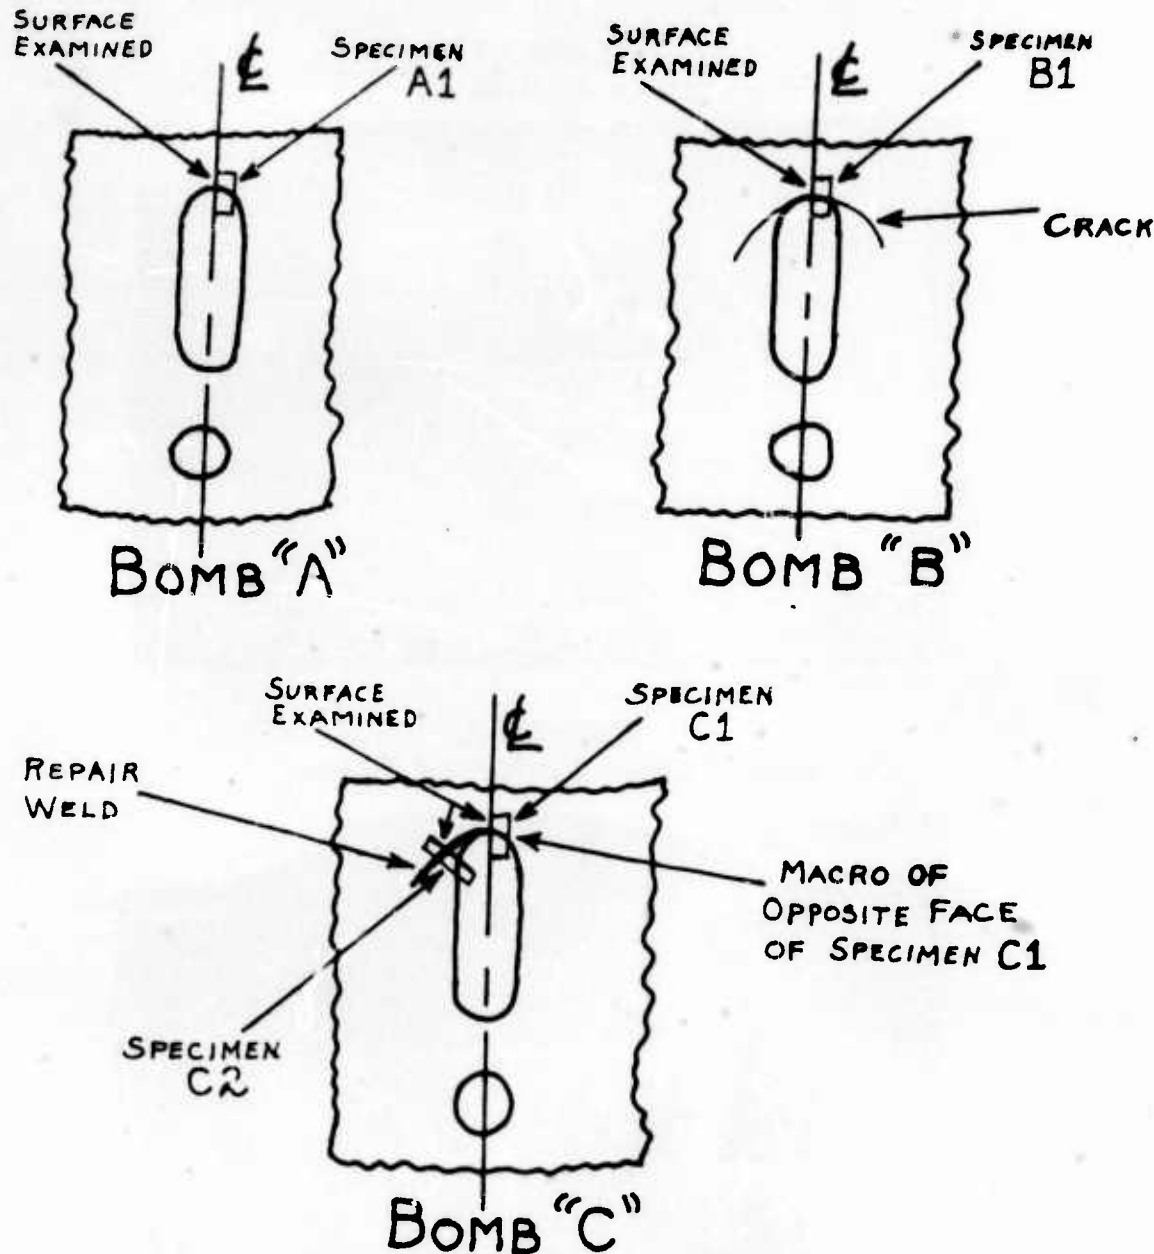
Fig. 6. Lug Insert Welds of Test Bomb Casings A, B, and C.

21. Examination of Lug Insert Welds: Sections of lug insert welds were taken from the three bomb casings (Fig. 6) so that in each case the section of Specimen No. 1 examined was approximately in the centerline of the lug insert. Macrographs of these sections are shown in Figures 7 and 8. As a point of interest, a macrograph of the opposite face of Specimen C1 is shown in Figure 8.

27. As shown in Figure 6, a typical example, quench cracking occurred approximately at right angles to the centerline of the lug insert, and the crack was tangent to the weld at the centerline of the lug insert. Except for a short distance in the region of tangency, the crack was not associated with the lug insert weld but extended into the bomb casing away from the weld.

The lug insert should be made to fit snugly against the casing wall during manufacture. The welding process should also be studied and a method established which will increase the weld penetration in width. The weld should extend to the edge of the insert boss, completely filling the space between the lug insert boss and the wall body, thereby eliminating one possible "triggering mechanism" for cracking.

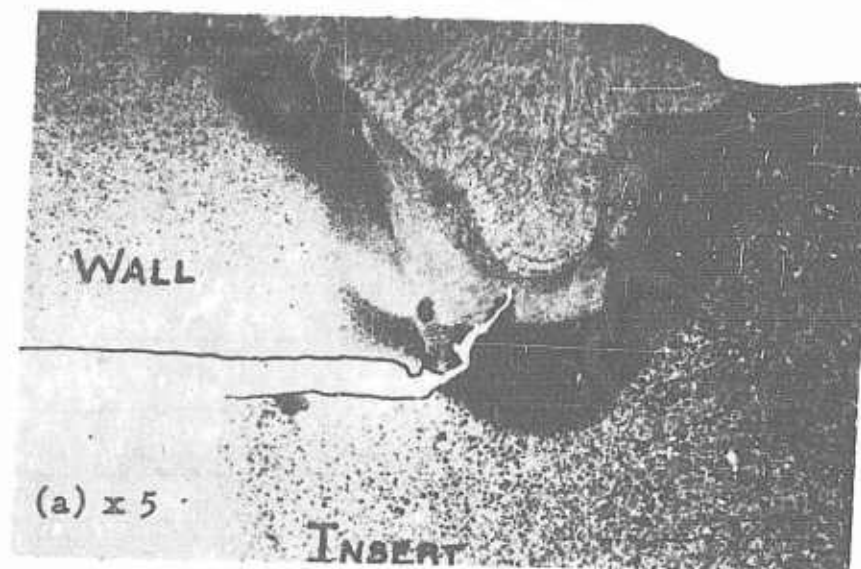
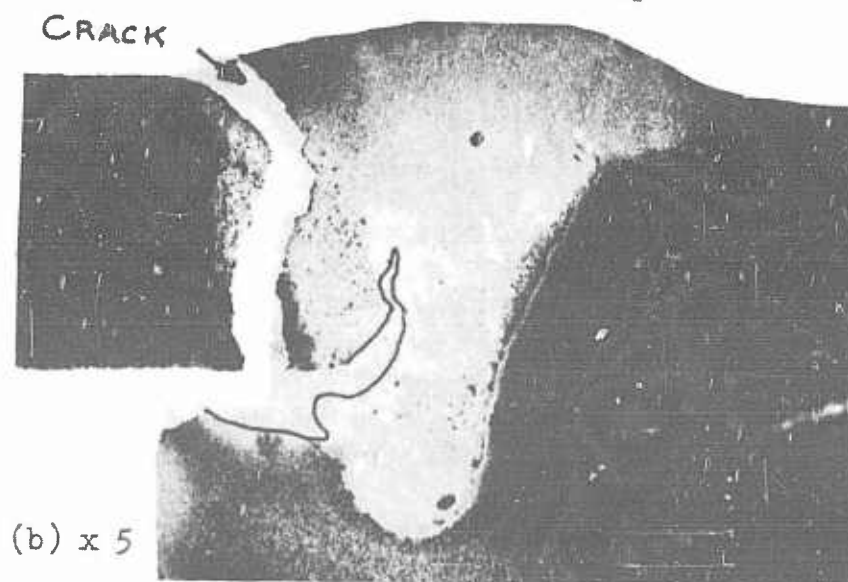
SPECIMEN A1
Bomb A As Welded

SPECIMEN B1
Bomb B After Quench and Temper

Fig. 7. Lug Insert Welds of Casings A and B,
Showing Cracks in Casing Wall.

44. Review of lug insert examination results indicates that the lug insert did not fit the opening in the casing wall accurately enough to fit snugly against the inside of the casing wall prior to welding. This condition caused a tendency to the root cracking of the weld metal. A root crack was present in the first, or root layer of weld metal. The peculiar nature of the welding process was also a contributing factor to the root cracking because the process gave a penetration great in depth but restricted in width. This condition resulted in a constriction of the weld metal, at the root of the joints where the poor fit of the back-up produced a sharp re-entrant angle on the side of the casing wall, that was believed to be a contributing factor to root cracking upon cooling of the weld.

45. Root cracking was not associated with cracking of the casing wall during the heat treatment cycle, since the casing cracked through the heat-affected zone, contiguous to the toe of weld reinforcement and away from the bond line, over the inner half of the casing wall thickness. This indicated that cracking was "triggered" by restraint of the lug insert mass and weld

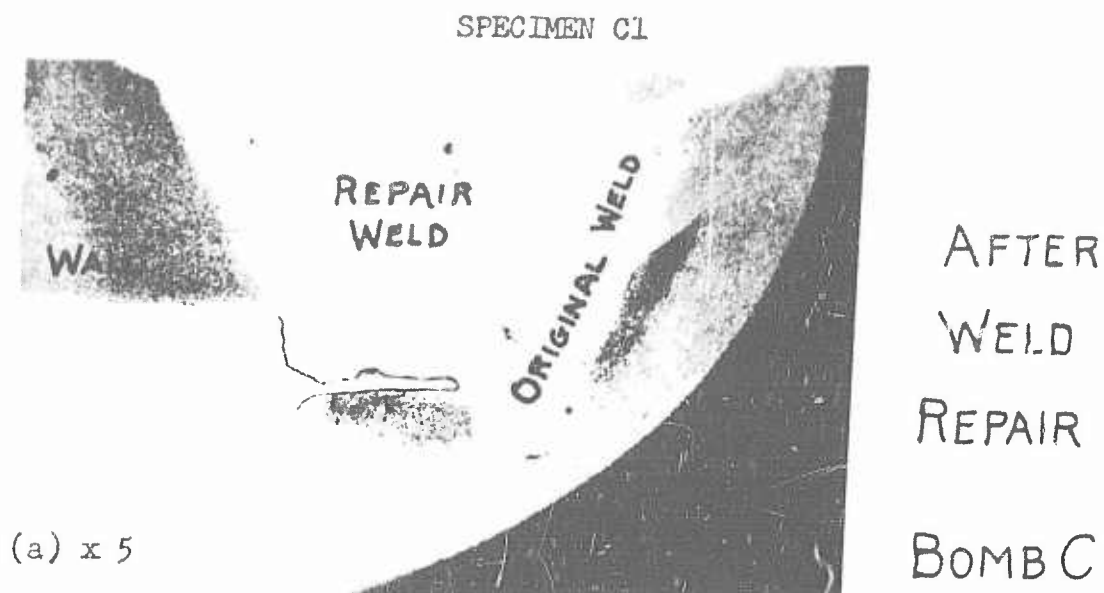
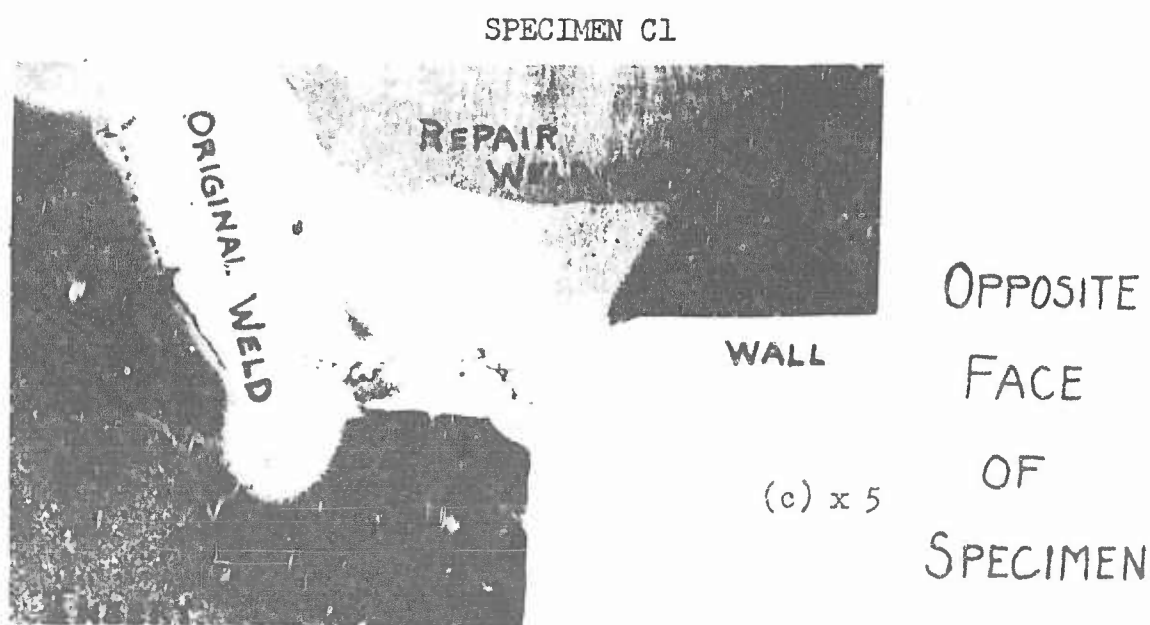
22. A second specimen, C2, was taken from Bomb C to give a cross section of the repair weld and a section of the insert weld. The black dots in the macrographs indicate approximately where photomicrographs were taken.

Fig. 8. Bomb Casing C with Lug Insert Weld Repaired.

43. The repair weld on the lug insert showed that the structure in the surface layer was not reheated by a subsequent layer. This indicated that the tempering had a negligible effect on weld metal structure.

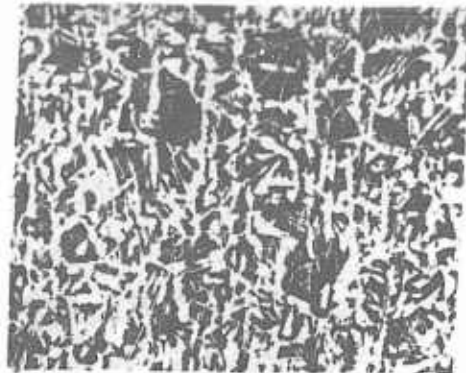
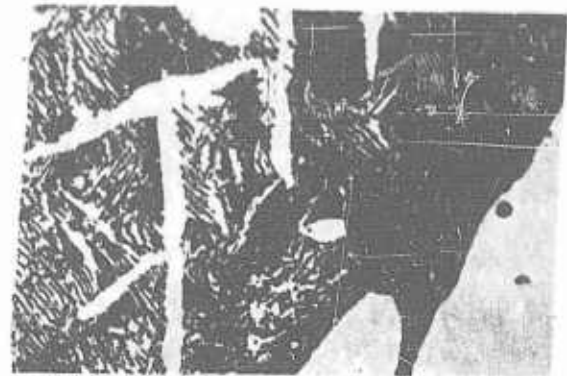
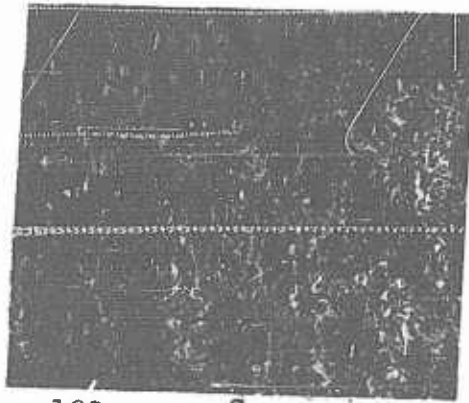
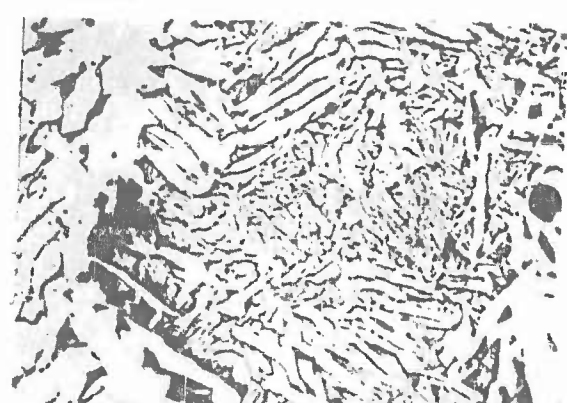
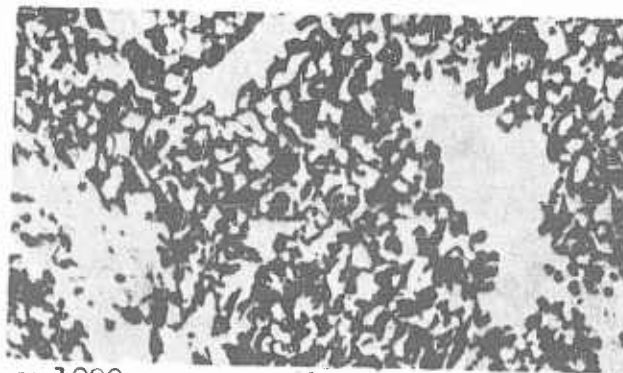
23. Photomicrographs in Figure 9 were taken from the location on Bomb A, shown in Figure 7, to show the "as welded" condition. The bomb casing wall was a hot-worked metal with a banded, coarse pearlitic structure, and the weld metal had a coarse dendritic structure with some pearlite. Figure 9E shows the coarse pearlite of base metal in the heat-affected zone was refined considerably by successive heat applications of the two weld layers.

Fig. 9. Photomicrographs of the "As Welded" Condition of Lug Insert Section of Test Bomb Casing A.

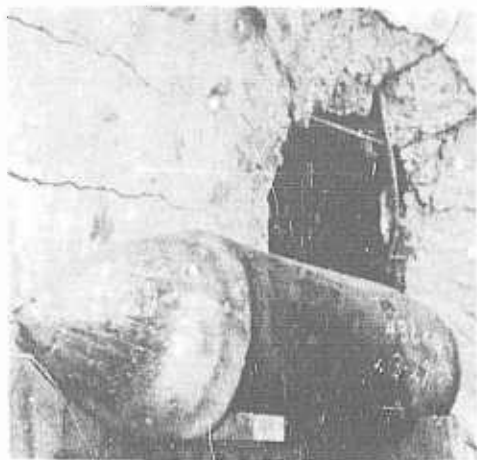
30. The first bomb, with a mean velocity of 1010 ft/sec, was fired 29 March 1956, against 16-inch, single-thickness reinforced concrete, instead of the 18-inch requested by Reference B. An 18-inch target was not available and previous results had indicated that this bomb would not penetrate 20 inches of concrete and remain effective. Nose plug and nose area were in good condition. Figure 10 shows that the body was uncracked and, except

Fig. 10. Target Penetration and Fold at Ogive Base of First Bomb.

for a 180-degree fold around the base, was in good shape. However, the bomb base was torn open, the explosive cavity exposed, and the base well broken and deformed (Fig. 11).

48. The first bomb fired was considered ineffective because the base closure failed. A body fracture and resulting exposure of the explosive cavity made the second bomb ineffective. Separation of the external base ring from the body, exposure of the explosive cavity, and a fracture along the weld rendered the third bomb ineffective.

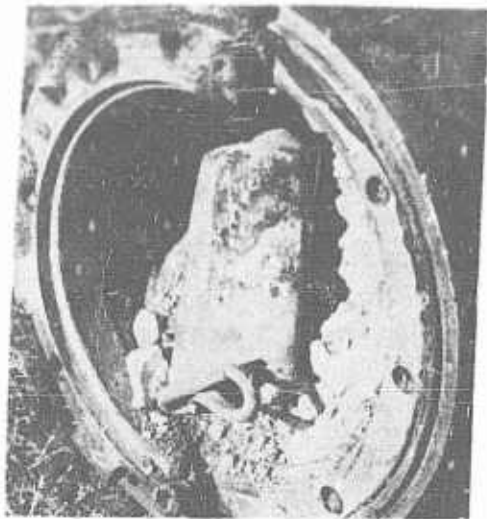
Fig. 11. Base of Recovered Bomb, Showing Broken External Base Ring, Missing Base Plug, and Distorted Fuze Cavity Liner.

There should be an investigation of base closure construction, and development of a design capable of withstanding the impact of the bomb against a concrete target. Parenthetically, it should be noted that failure in this area is not limited to the design herein considered. It is recommended that repair welding be considered acceptable, provided the repair weld is examined carefully by radiographic or other means to assure complete closure of the crack.

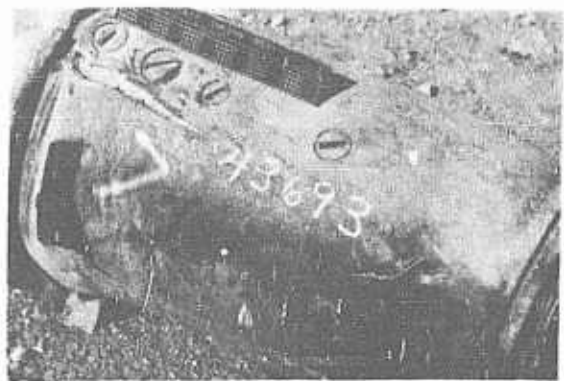
but the body fractured along the weld for the multiple lug insert (Figs. 12 and 13), and a heavy 300-degree fold appeared around the main base of the ogive (Fig. 14). The external base ring was partially separated from the body of the bomb as shown in Figure 12.

Fig. 12. Second Bomb, Showing Fold at Junction of Ogive and Body, Split Along Multiple Insert Weld, and Separation of External Base Ring.

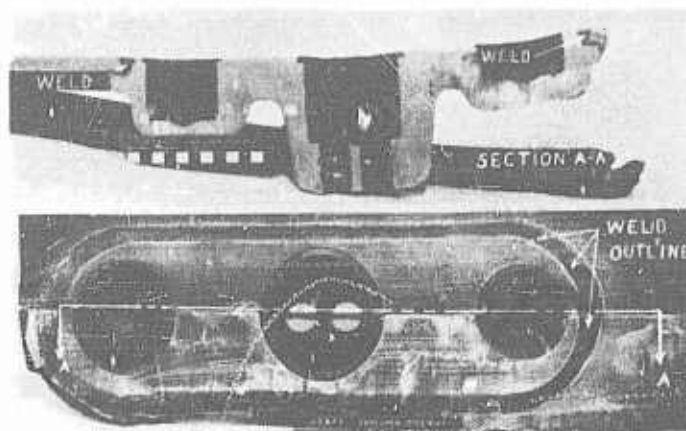
Fig. 13. Sectioned Multiple Lug Insert From Second Bomb, Showing Metal Failure Along Weld.

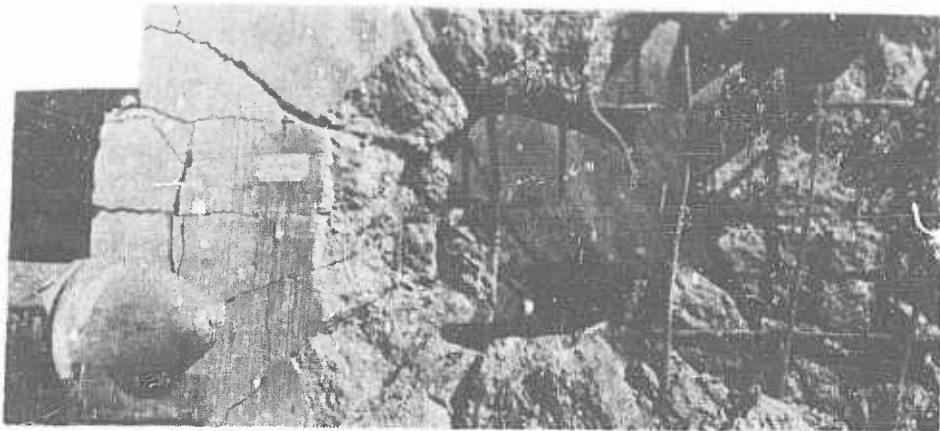
Fig. 14. Photo of Second Bomb Fired, Showing Fold at Base of Ogive and Penetration Through 20 Inches of Concrete.

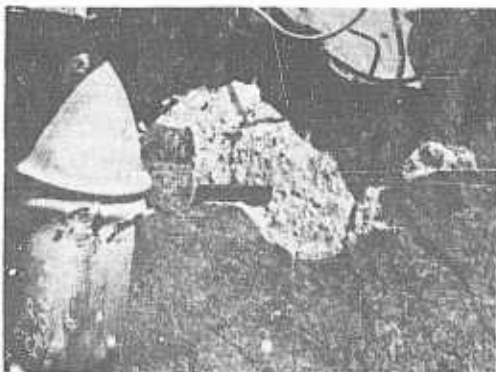
which extended 360 degrees around the body (Fig. 15). The external base ring was partially separated from the body (Fig. 16), and the body section had a fracture along the weld for the multiple lug insert (Fig. 17).

Fig. 15. Third Bomb Fired, Showing Heavy Folds Around Body.

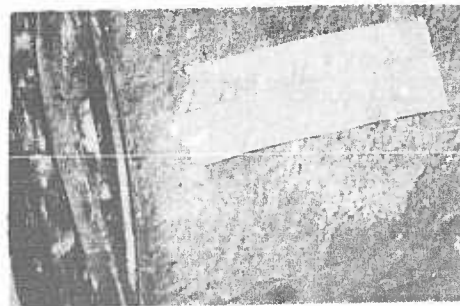
Fig. 16. Closeup of 3rd Bomb Base Showing Separation of External Base Ring and Exposed Cavity.

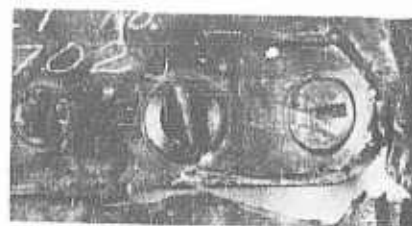
Fig. 17. Metal Failure Along Lug Insert Weld of Third Bomb Fired.

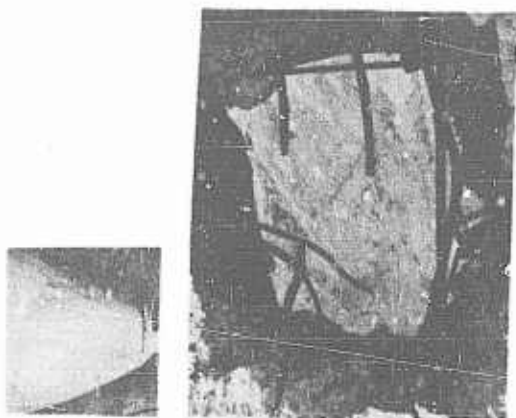
33. The fourth bomb was fired 18 April 1956, against 16-inch reinforced concrete. Mean velocity was 1013 ft/sec. The nose plug, nose area, and body were in good condition; the body had no folds

or bulges (Fig. 18). The external base ring in this bomb was broken and deformed, nevertheless, as shown by Figure 19, the explosive cavity was not exposed. The bomb remained effective.

Fig. 18. Nose of Fourth Bomb Appears in Good Condition Following Target Penetration.

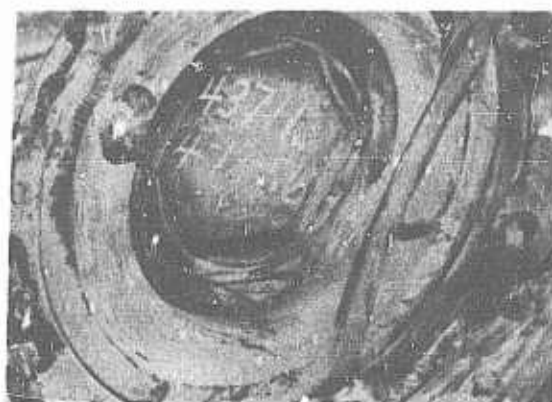
Fig. 19. Base of Recovered Fourth Bomb, Showing Broken External Base Ring and Sheared Rim on Base Plug.

49. Although its external base ring broke and deformed, the fourth bomb was considered effective because its explosive cavity was not exposed. The fifth bomb was also deemed effective because the body remained in good condition with the explosive cavity unexposed.

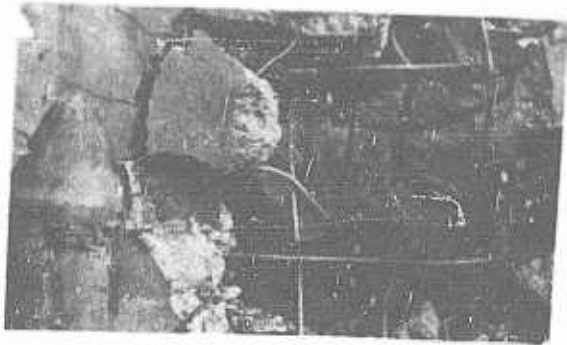
34. The fifth bomb was fired 26 April 1956, against 24-inch, laminated (three 8-inch slabs stacked together) reinforced concrete. Mean velocity was 988 ft/sec. The nose plug was in poor condition and had been forced into the nose fuze well, although the surrounding nose area was in good condition. The body was not damaged, except for a slight 180-degree bulge around the base of the ogive.(Fig. 20). A slight separation appeared between the external base ring and the body.

Fig. 20. Fifth Bomb Fired, Showing Penetrated Target and Bulge Around Base of Ogive.

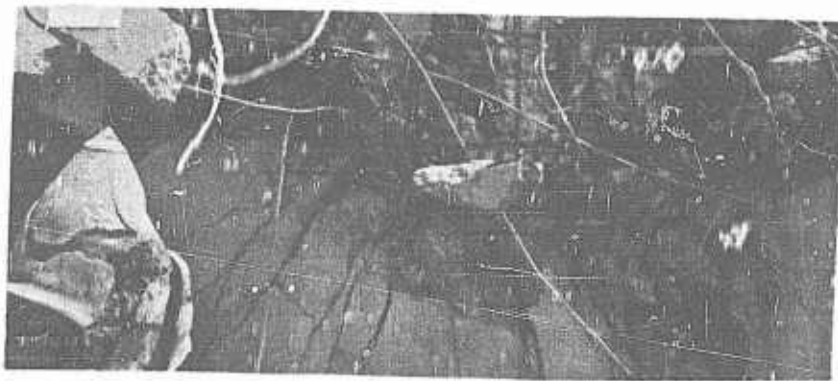
35. The sixth bomb was fired 2 May 1956, against 24-inch, laminated (two 12-inch slabs stacked together) reinforced concrete. Mean velocity was 1016 ft/sec. Although the nose plug was in good condition, the surrounding area was fractured (Fig. 21). The body was badly fractured but the bomb base was in good shape, and no cracks appeared near the insert weld (Fig. 22).

Fig. 21. Sixth Bomb Fired, Showing that Area Surrounding Nose Plug was Fractured, Although Plug was in Good Condition and Target was Penetrated.

50. A badly fractured body made the sixth bomb ineffective; however, it should be noted that this bomb was fired against a target heavily reinforced (in a cubic fashion) with 3/8-inch bars on six-inch centers.

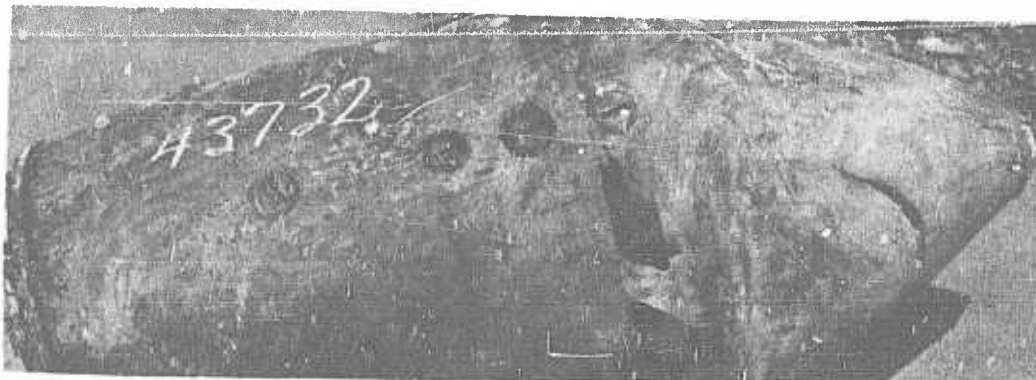
Fig. 22. Sixth Bomb Fired with Base in Good Condition and Lug Insert Weld Area Free from Cracks.

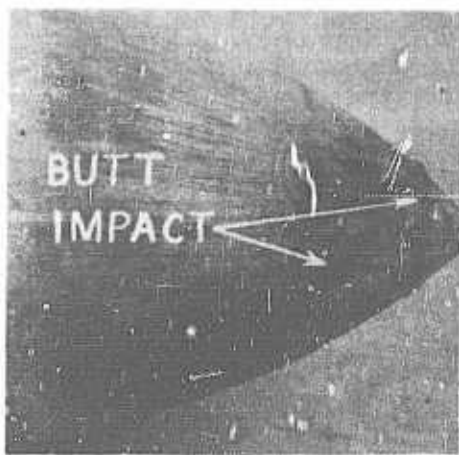
resulted from secondary impact (Fig. 23). The base of the seventh bomb was in good condition and so was the body. However, as shown in Figure 24, a 180-degree fold appeared at the base of the ogive.

Fig. 23. Seventh Bomb Fired, Showing Dent from Secondary Impact.

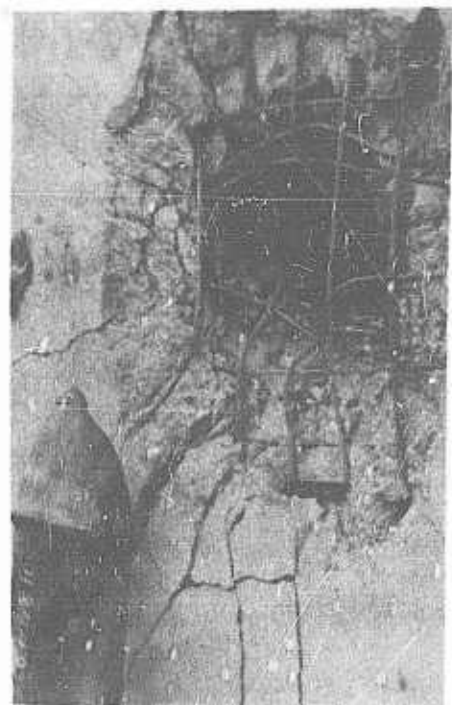
Fig. 24. Photo Showing How Seventh Bomb Penetrated Target.

51. The seventh bomb was in an effective condition because both body and base were in very good shape.

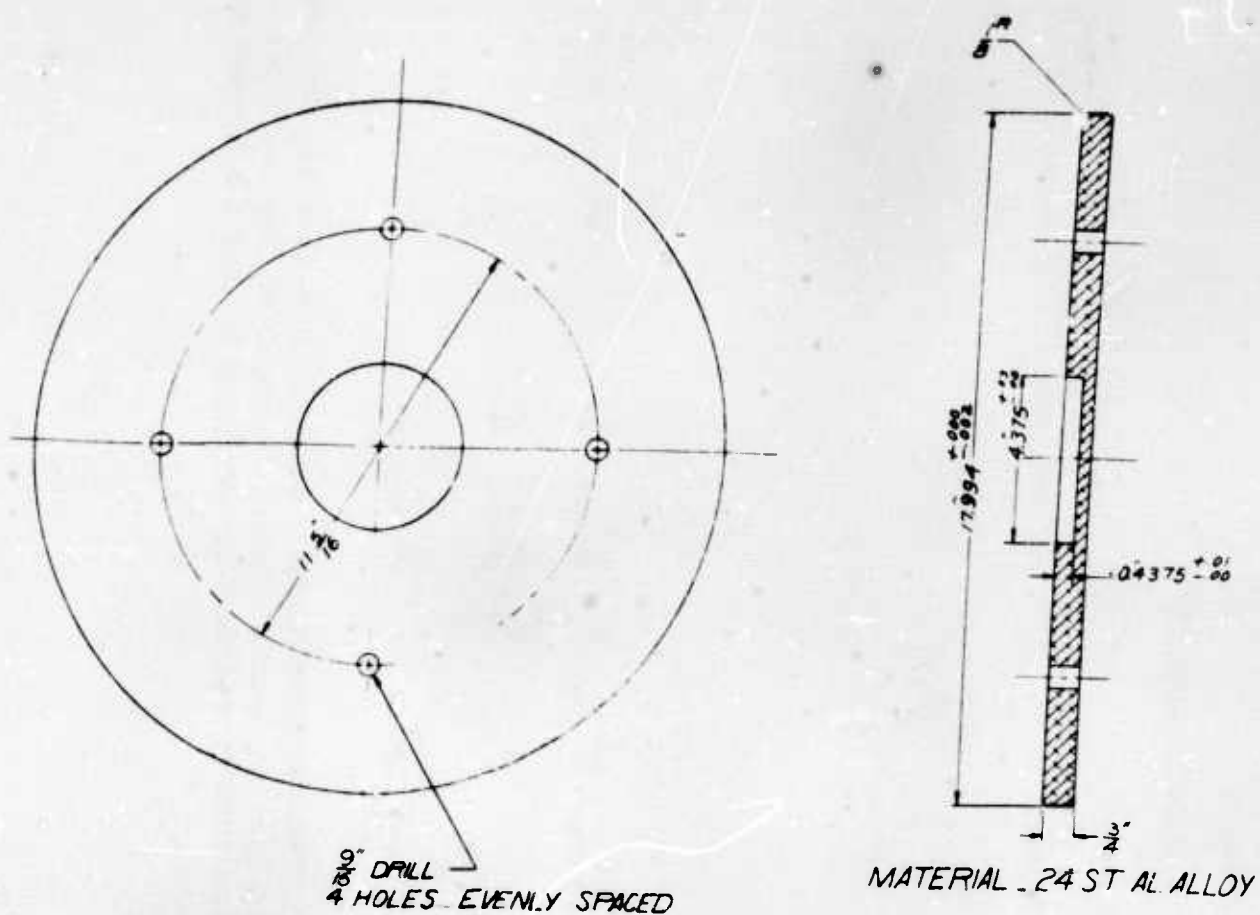
Fig. 26. Pressure Plate for .750-Pound Bomb.
